NATIONAL PROGRAM FOR INSPECTION OF NON-FEDERAL DAMS
SLEEPER DAM (ME 00014) (U) CORPS OF ENGINEERS WALTHAM
MA NEW ENGLAND DIV JUN 79

SLEEPER DAM ME-00014

PHASE I INSPECTION REPORT NATIONAL DAM INSPECTION PROGRAM

JUNE 1979

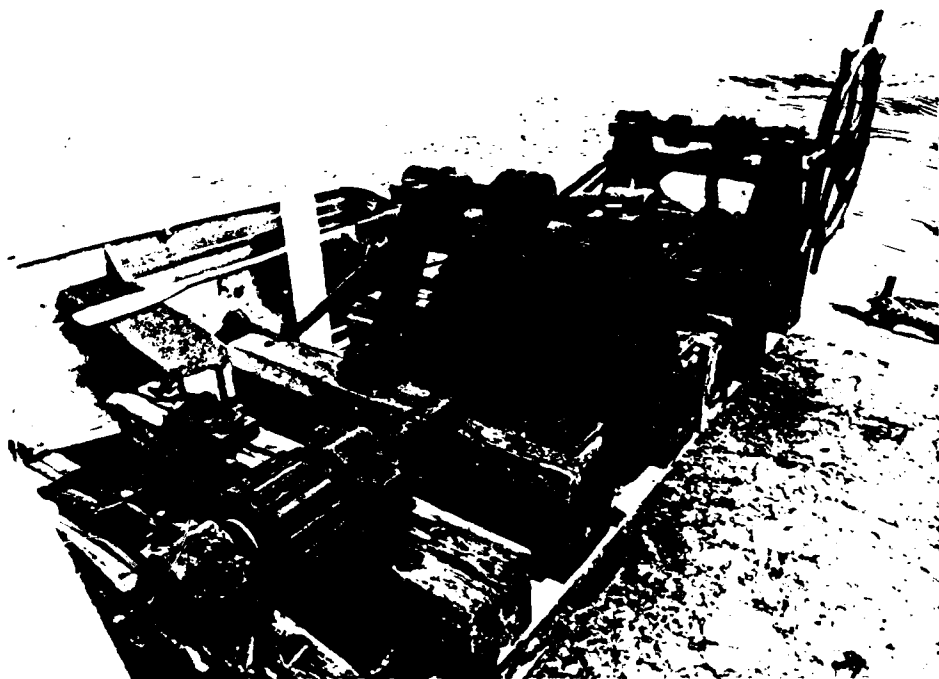
4

- c. Appurtenant Structures. Some leakage was occurring around the control outlet gates. The hoisting equipment appeared to be in fair condition but the lifting stems on the gates have been broken, rendering the gates inoperable.
- d. Reservoir Area. The reservoir consists of Sabattus Pond, which has a surface area of about 2,050 acres. There are many cottages and some permanent residences on the reservoir shoreline.
- e. Downstream Channel. The channel immediately downstream of the dam is comprised of bedrock and cobbles. There are also some boulders about 2 feet in diameter downstream of the dam, especially on the easterly side. The banks of the river have a moderate growth of trees and brush (see Photo #2). About 700 feet downstream of the dam is a breached dam and a bridge crossing. About 1,500 feet downstream of the dam the river makes a 180° bend.

- b. Operating and Control Gates. The gates consist of two vertical lift timber gates. The lifting stems on the gates have been broken and the gates are presently inoperable (see Photo #4). The hoisting equipment with the exception of the lifting stems appears to be in fair to good condition.

GATE OPERATING EQUIPMENT

- (1) Repair of spalled concrete surfaces.
- (2) Repair of the outlet gates and operating equipment to return these gates to operable condition.
- (3) Clearing of trees and brush from the left abutment to provide better flow characteristics and to lessen deterioration of the bedrock surface and mortar-laid masonry fill.
- (4) Provide around-the-clock surveillance during periods of anticipated high runoff.
- (5) Develop a formal warning system and implement its use in the event of an emergency.
- (6) Have inspections of the dam made by Registered Professional Engineers once every year.

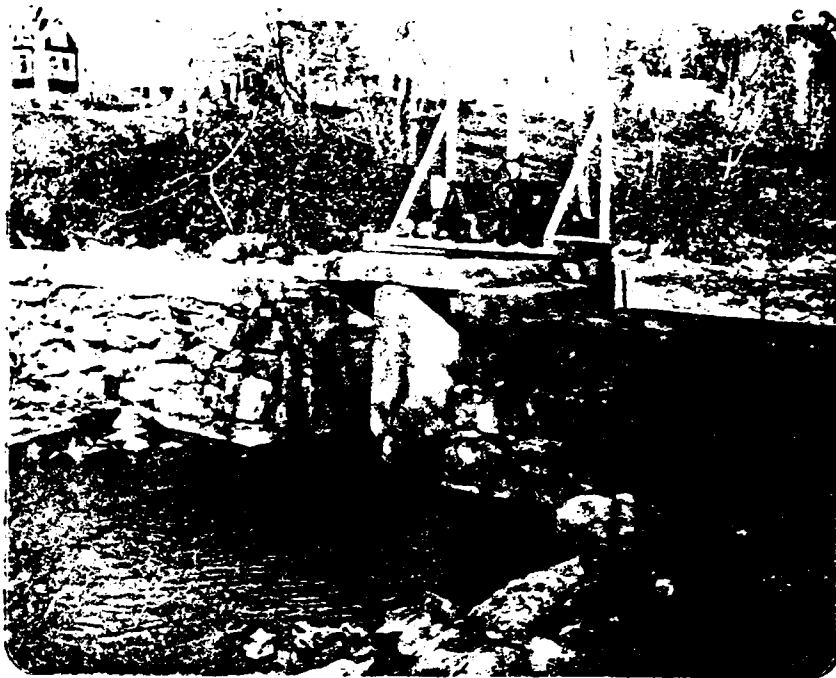
- (b) The overall dam structure appears true to line and grade. No lateral deflection or settlement is apparent.
 - (c) The concrete surfaces on the structure are generally in good condition. The lower portion of the outlet sluiceway and the inlet structures are spalled quite deeply (see Photos #6, 7, & 8).

- c. Conduits, Sluices and Water Passages. The interior surfaces of the sluiceway appear to be in generally good condition. Substantial spalling and erosion has occurred on the lower portion of the sidewalls and the central pier (see Photos #6, 7 and 8). No serious leakage is occurring into the outlet conduit.

DOWNSTREAM FACE

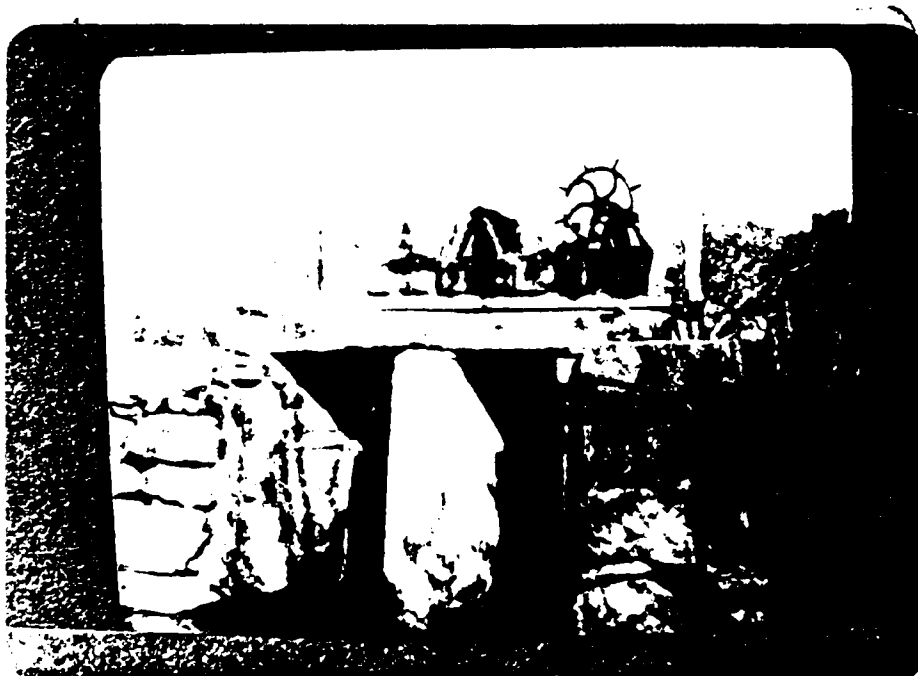
8

GATED OUTLET SLUICE
